The Emerging Flood Risk on the Lower Part of Transboundary Meric/Maritsa River Basin

Abstract

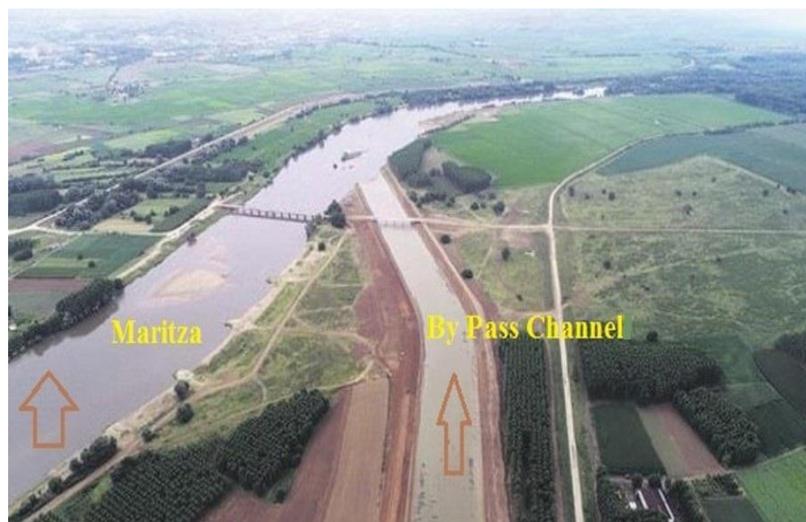
Figure 1b. Bypass Channel and Meric River.

Flood protection measures in Turkey have become an urgent matter and Turkey has decided to take its own measures. Turkey built a bypass channel to protect Edirne City and agricultural lands (Fig. 1 b)

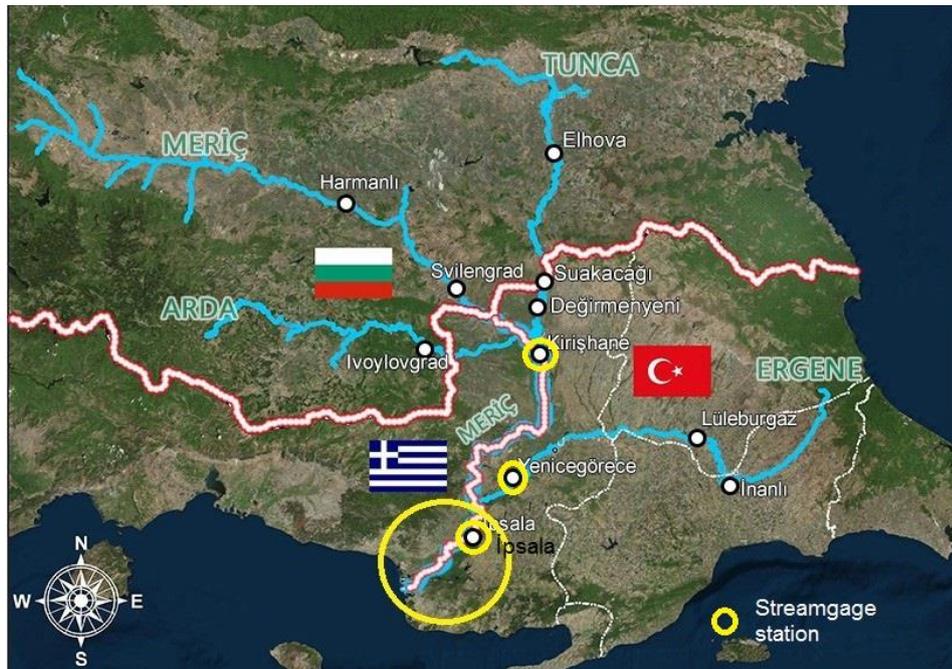
Figure 12. Lower Part of the Meric Basin and used streamgauge stations in this study

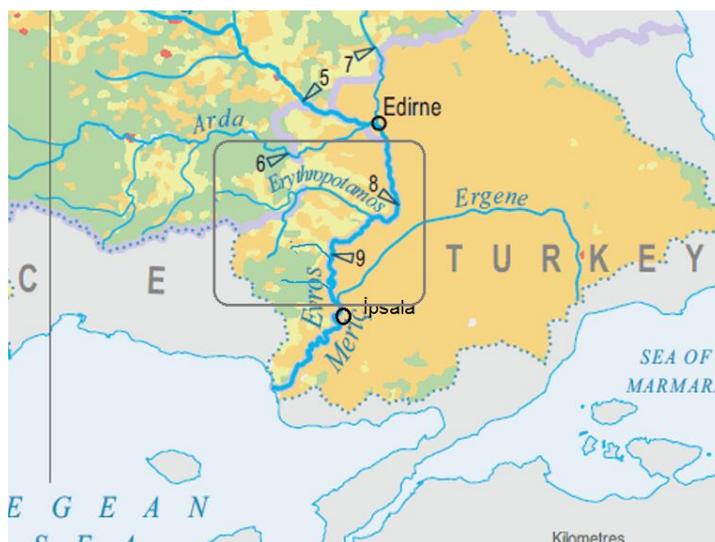
Figure 13. Inter basin of Meric River between Edirne and İpsala city.

The Erythrotamos River is the largest river which flows into the Meric River in the Inter Basin between Edirne and İpsala excluding Ergene River (Fig. 13). It is born in Bulgaria and after running for about 10 km on and alongside with the Greek Bulgaria border. It enters Greece and flows into the Meric River at the level of the town of Didymotichon.

Amount of streamflow's enters to Meric River along the inter basin between Edirne and İpsala is not available (Fig. 13). Therefore, we calculated it using daily average online data and considering travel time between two streamgauge stations given in the article (1), due to focusing on flood risk assumption in the lower part of the Meric Basin we used data of flood period of time (Jan-April). Used data for this calculation was also compared to each other's for the similarity .Correlation coefficient was obtained as of 0,96 (Fig. 14).
